Docket No. 217 – Development and Management Plan Inspection

Northeast Utilities Service Company Certificate of Environmental Compatibility and Public Need for the construction of a 345-kV electric transmission line and reconstruction of an existing 115-kV electric transmission line between Connecticut Light and Power Company's Plumtree Substation in Bethel, through the towns of Redding, Weston, and Wilton, and to the Norwalk Substation in Norwalk, Connecticut.

Date: July 19, 2006

Location: Transition Stations: Hoyts Hill, Archers Lane, Norwalk Junction

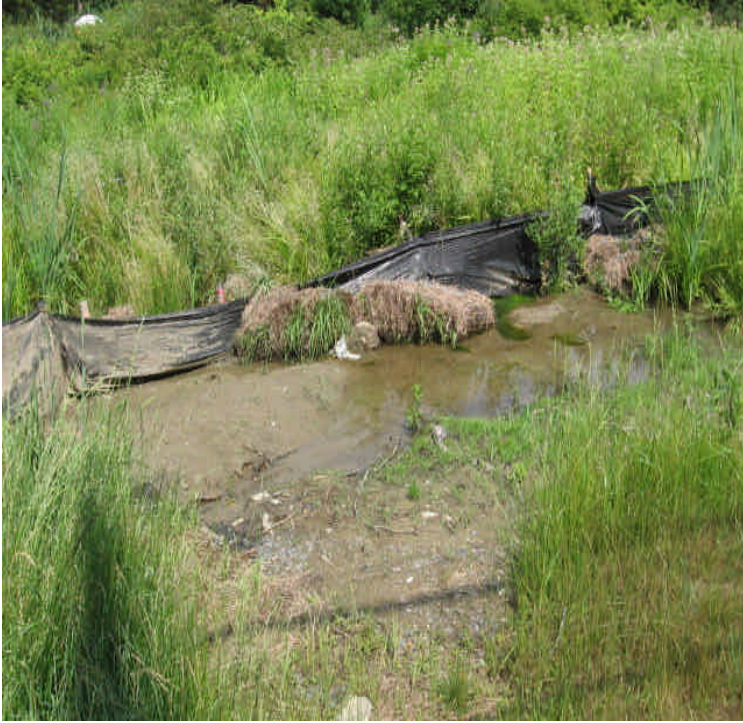
Hoyts Hill Transition Station: Photo on the left shows where the old filter bag had been during construction. Consider seeding here to restore temporary vegetative cover. Photo on the right shows a view of the existing gully along the slope. 7/19/06

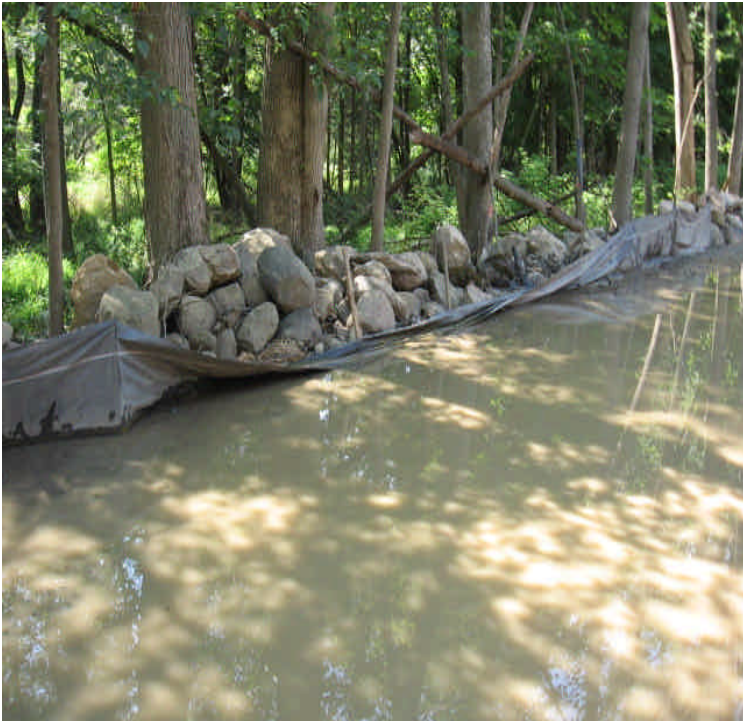
Archers Lane: Photo on the left shows turbid run-off ponding at the access drive. Continue to maintain controls so this water is filtered before entering the wetland. If this ponding is an issue consider haybales or small stone berms in place of silt fence Photo on the right shows an overview of the work and structures in the station yard. 7/19/06.

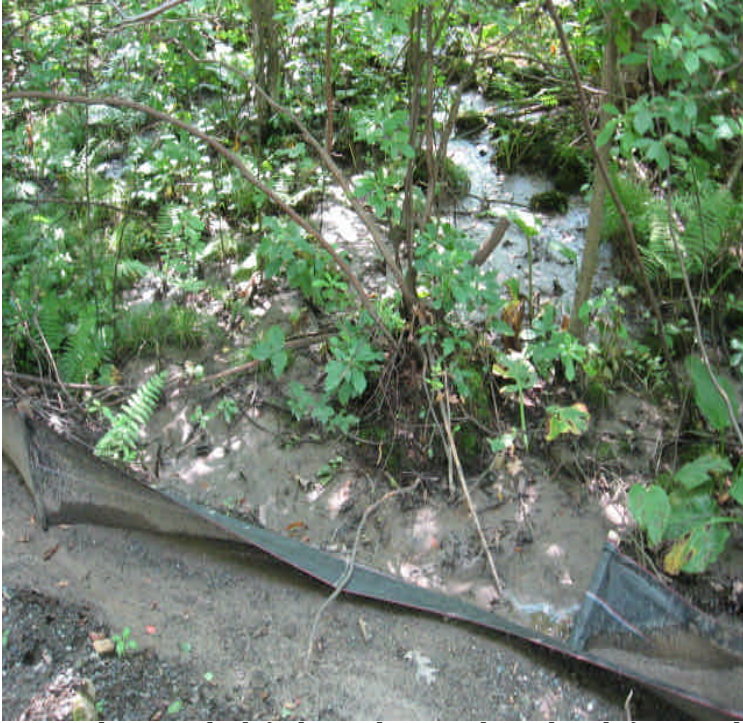
Photo on the left shows the area along the silt fence at the 1st wetland crossing that receives significant run-off from the access road. Sediment continues to accumulate in the wetland. Contractors are being scheduled to remove this but more final stabilization measures will be needed. Photo on the right shows some additional accumulation.

- The silt fence along the access road washed out in one obvious spot and sediment continued to accumulate in the wetland. 7/5-7/19/06 The second spot also had sedimentation after holding back a significant amount of water. 7/19/06	- The fence should be repaired and reinforced- Sediment needs to be removed carefully by hand in these spots. See erosion control section. 7/5-7/19/06 This area will also need some final stabilization measures as this is an ongoing problem.	- Needs attention (NU was lining up a contractor to look into this) - Needs evaluation

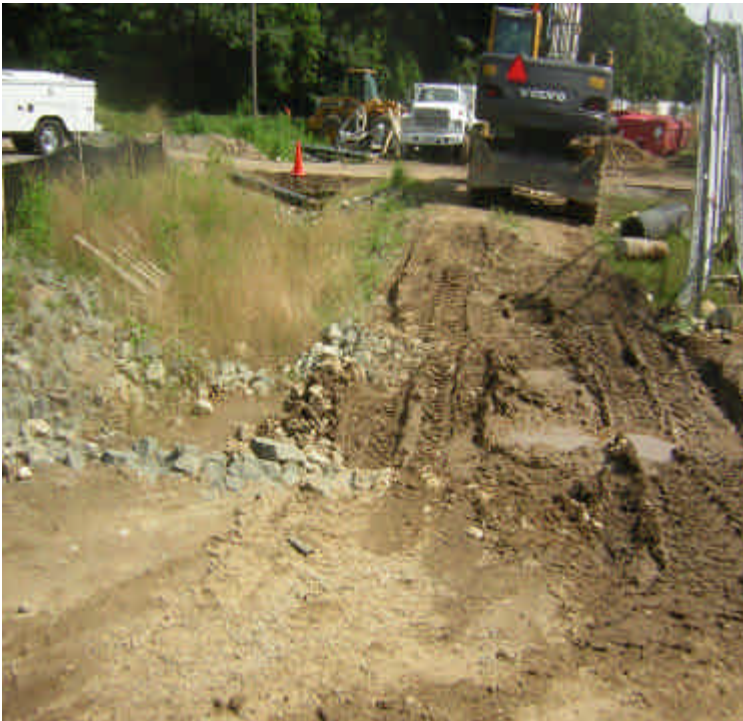
Norwalk Junction: Photo on the left shows where some vehicle traffic caused additional soil disturbance adjacent to the swale. Areas surrounding the swales should be restored where possible to reduce run-off. Photo on the right shows the wetland area at the end of the swale with accumulated sediment that should be removed. 7/19/06.
